APPENDIX B
PHOTOGRAPHS

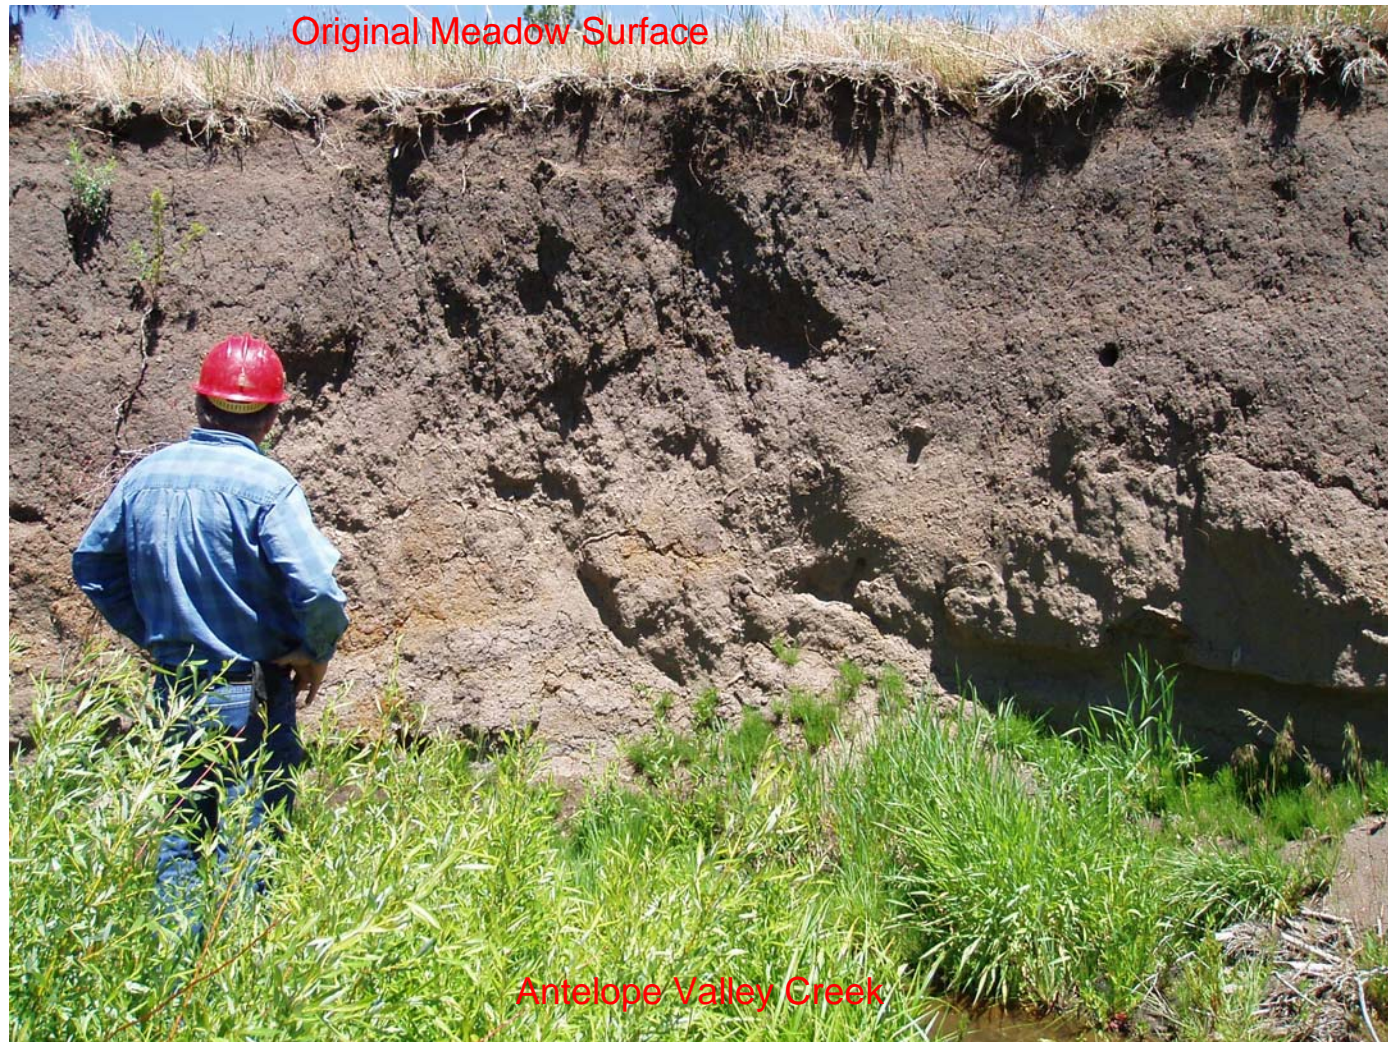
Photo 1

Vertical Bank of the Antelope Creek Entrenchment

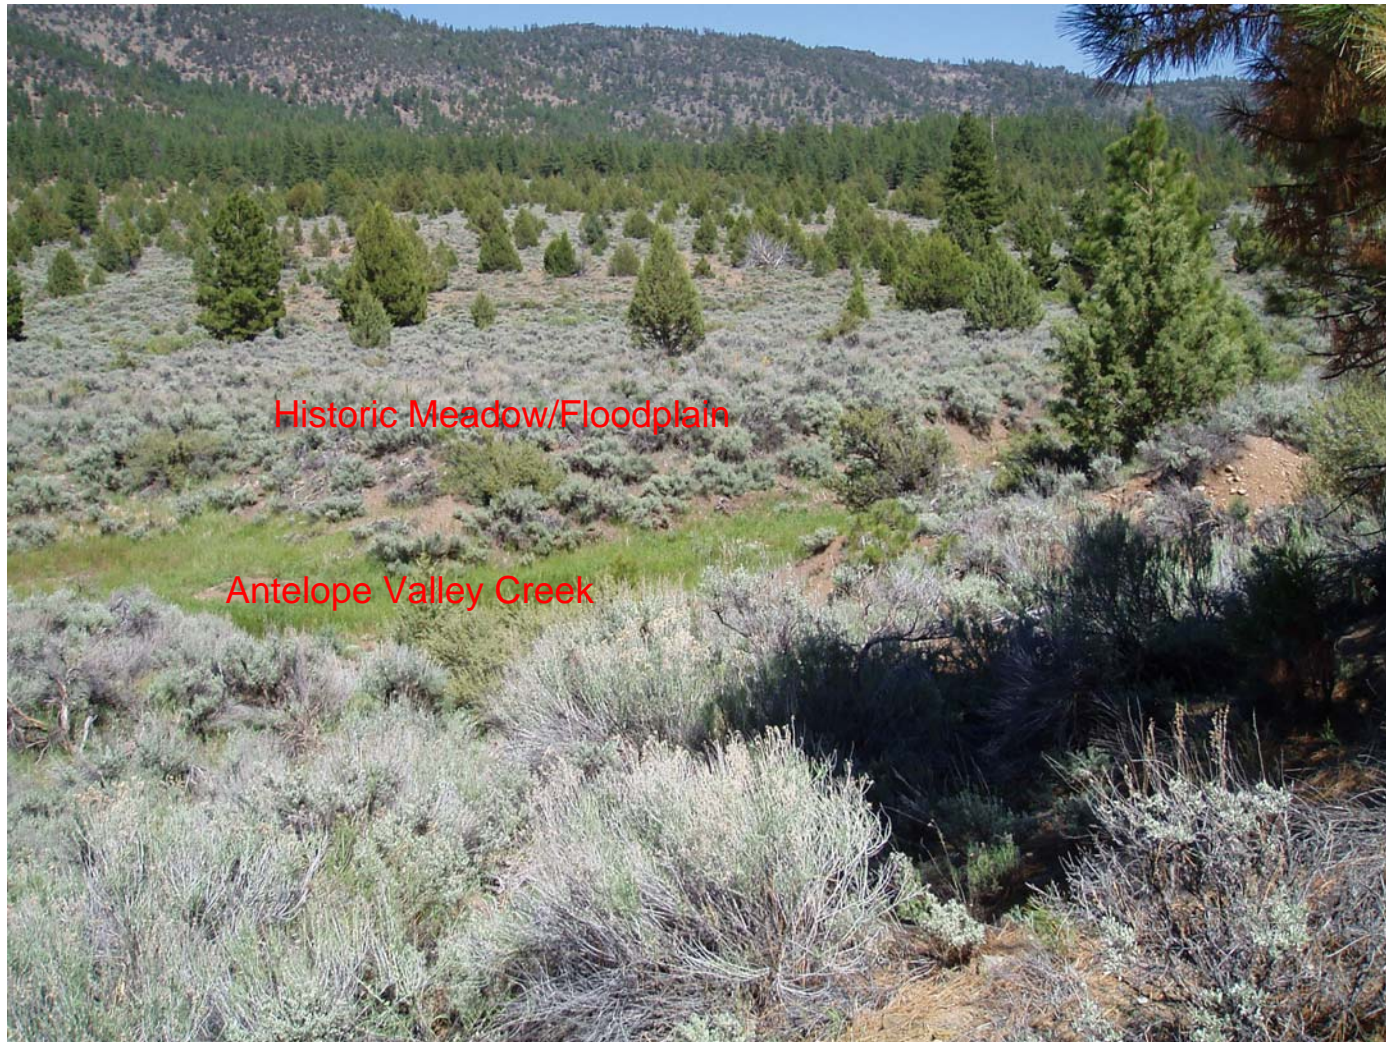
Photo 2

Antelope Valley Entrenchment

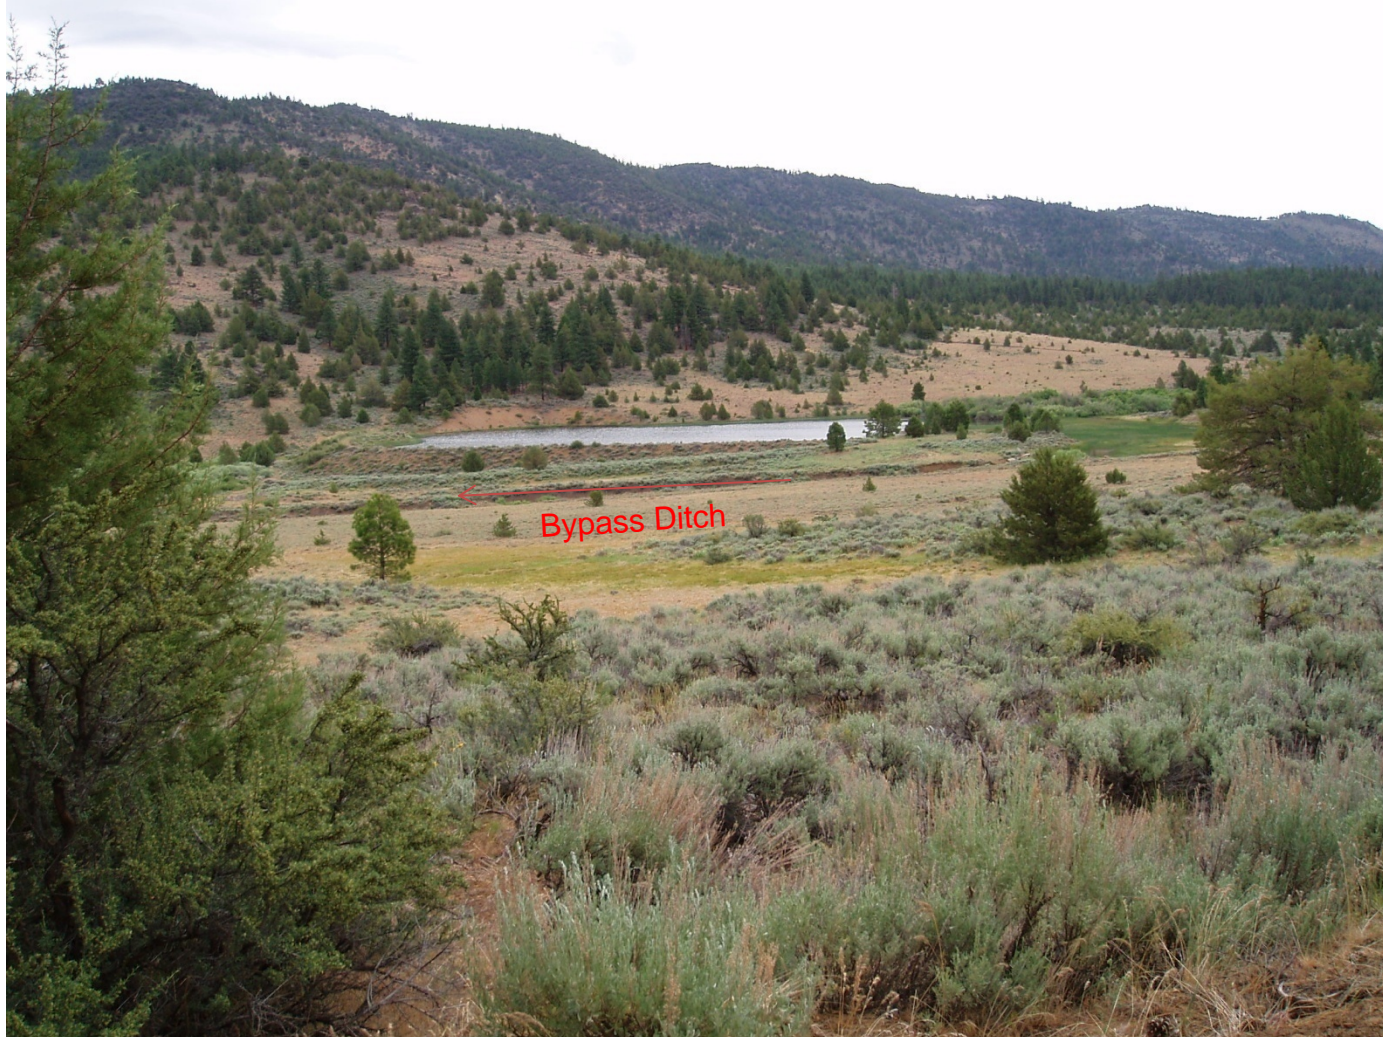
Photo 3

Palen Dam and Reservoir

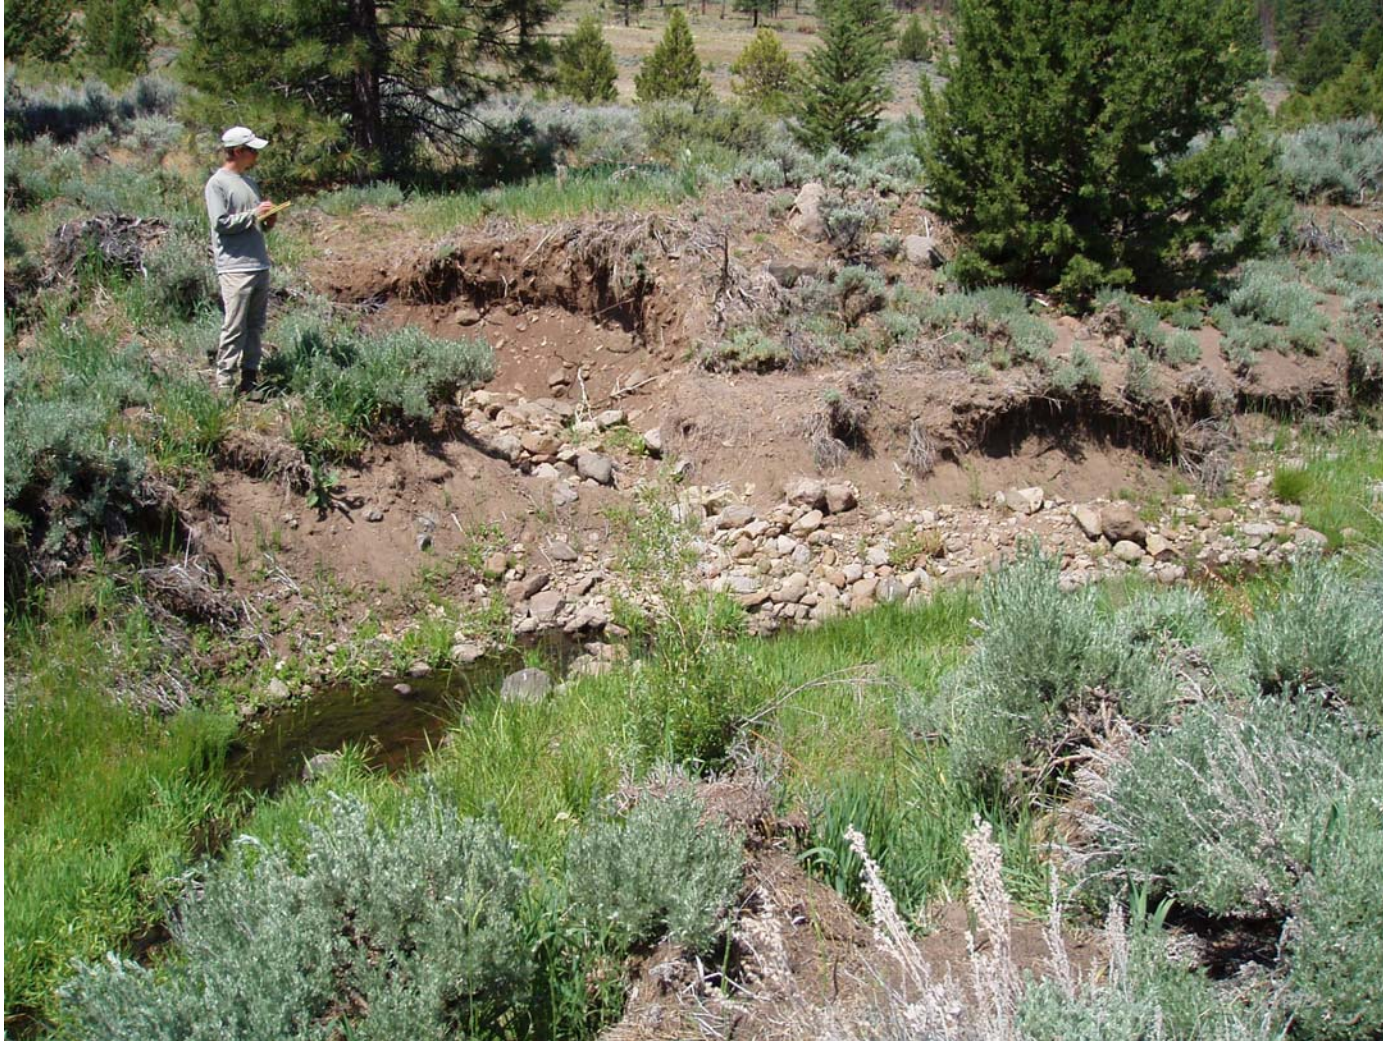
Photo 4

The Eroding Bottom and Banks of Antelope Valley Creek

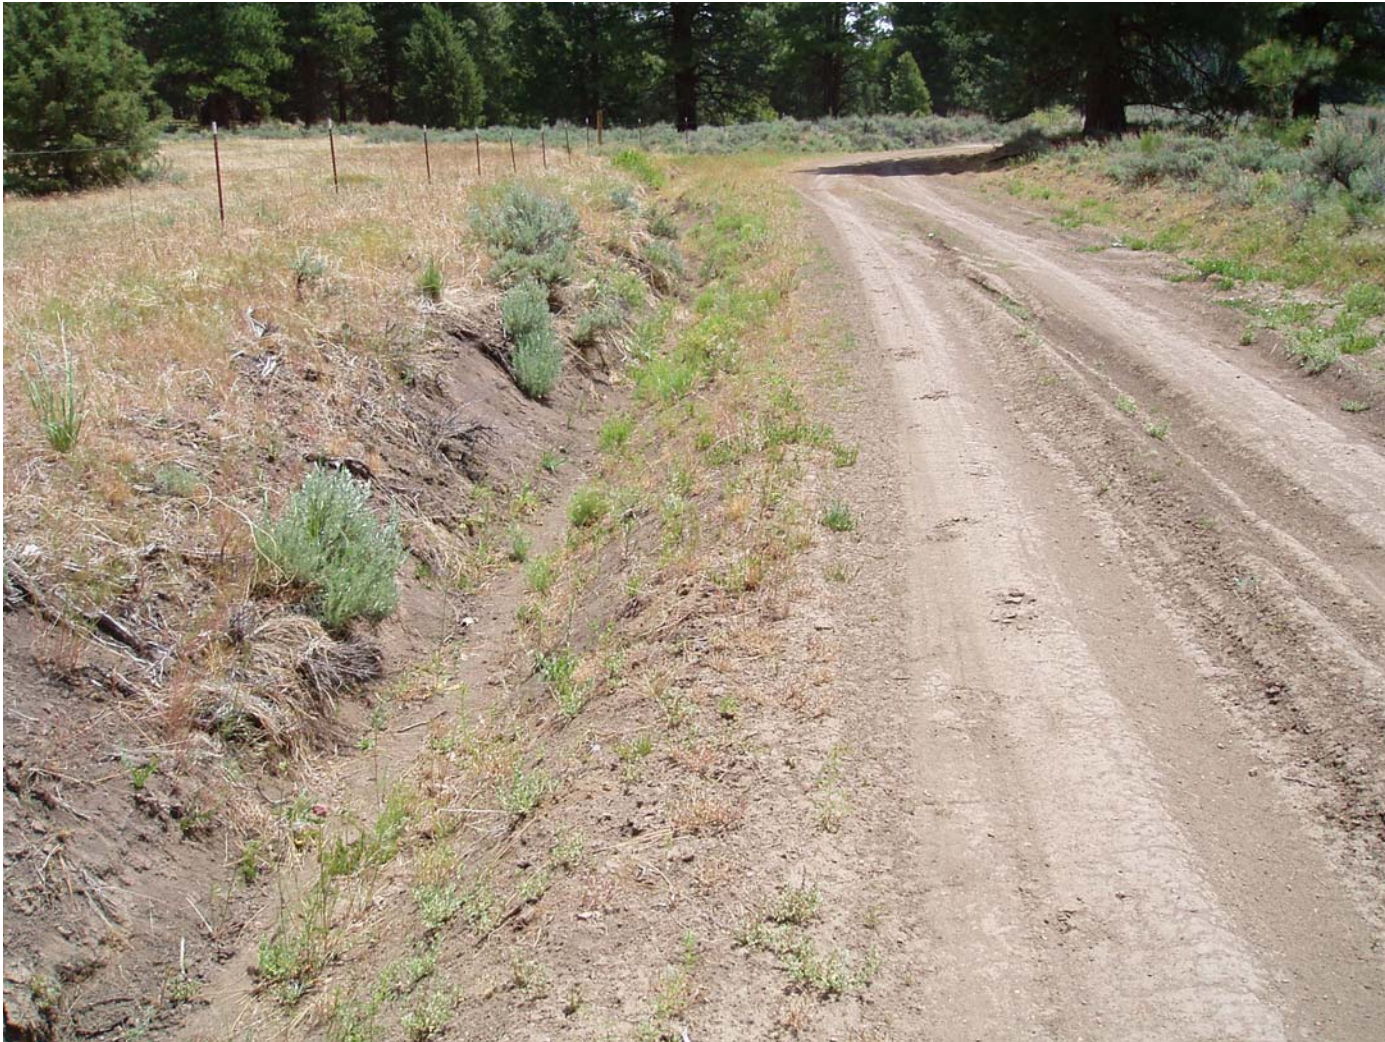
Photo 5

Tributary Stream Channel Caught in the Antelope Valley Road
Inside Ditch

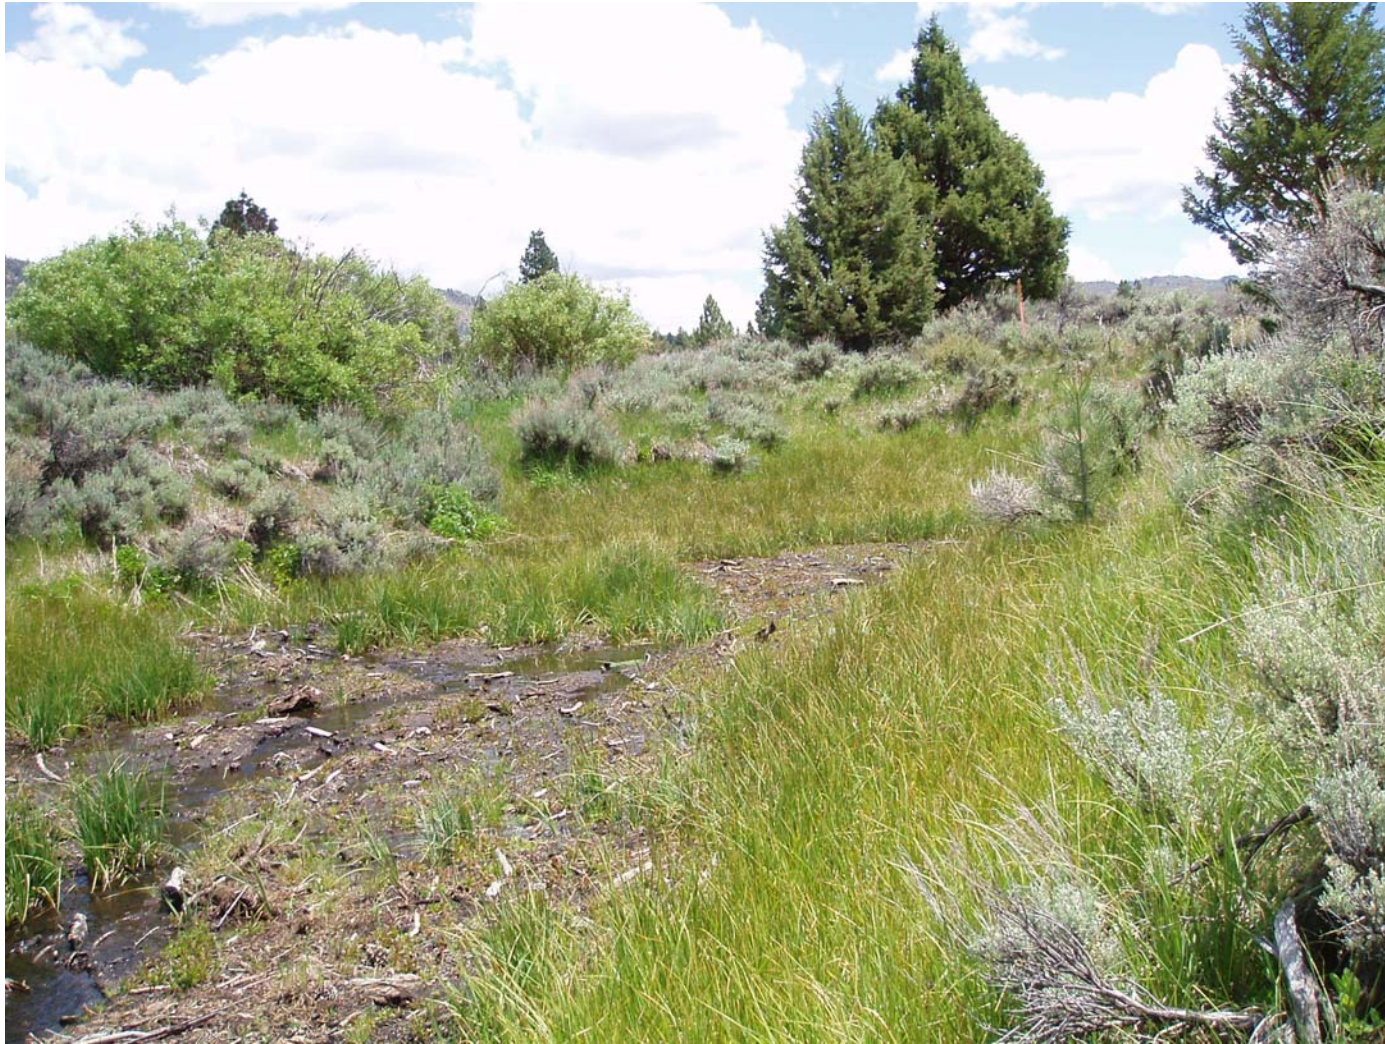
Photo 6

The Top of The Area Excavated to Supply Material For Palen Dam
Note Dewatering of the Meadow Above and the Sudden Drop in the Valley

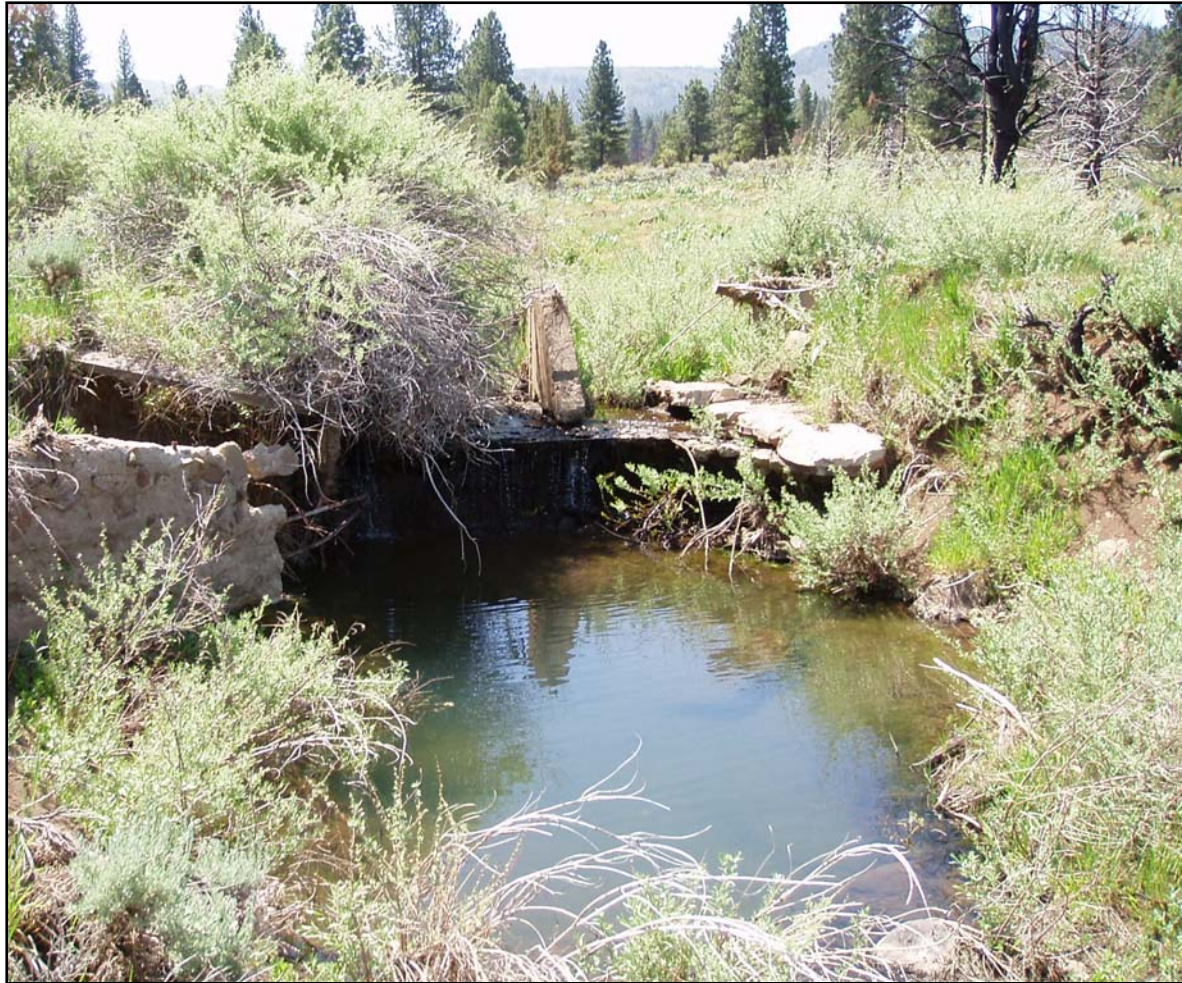
Photo 7

Palen Reservoir Bypass Diversion Dam
Note Its Deteriorated State

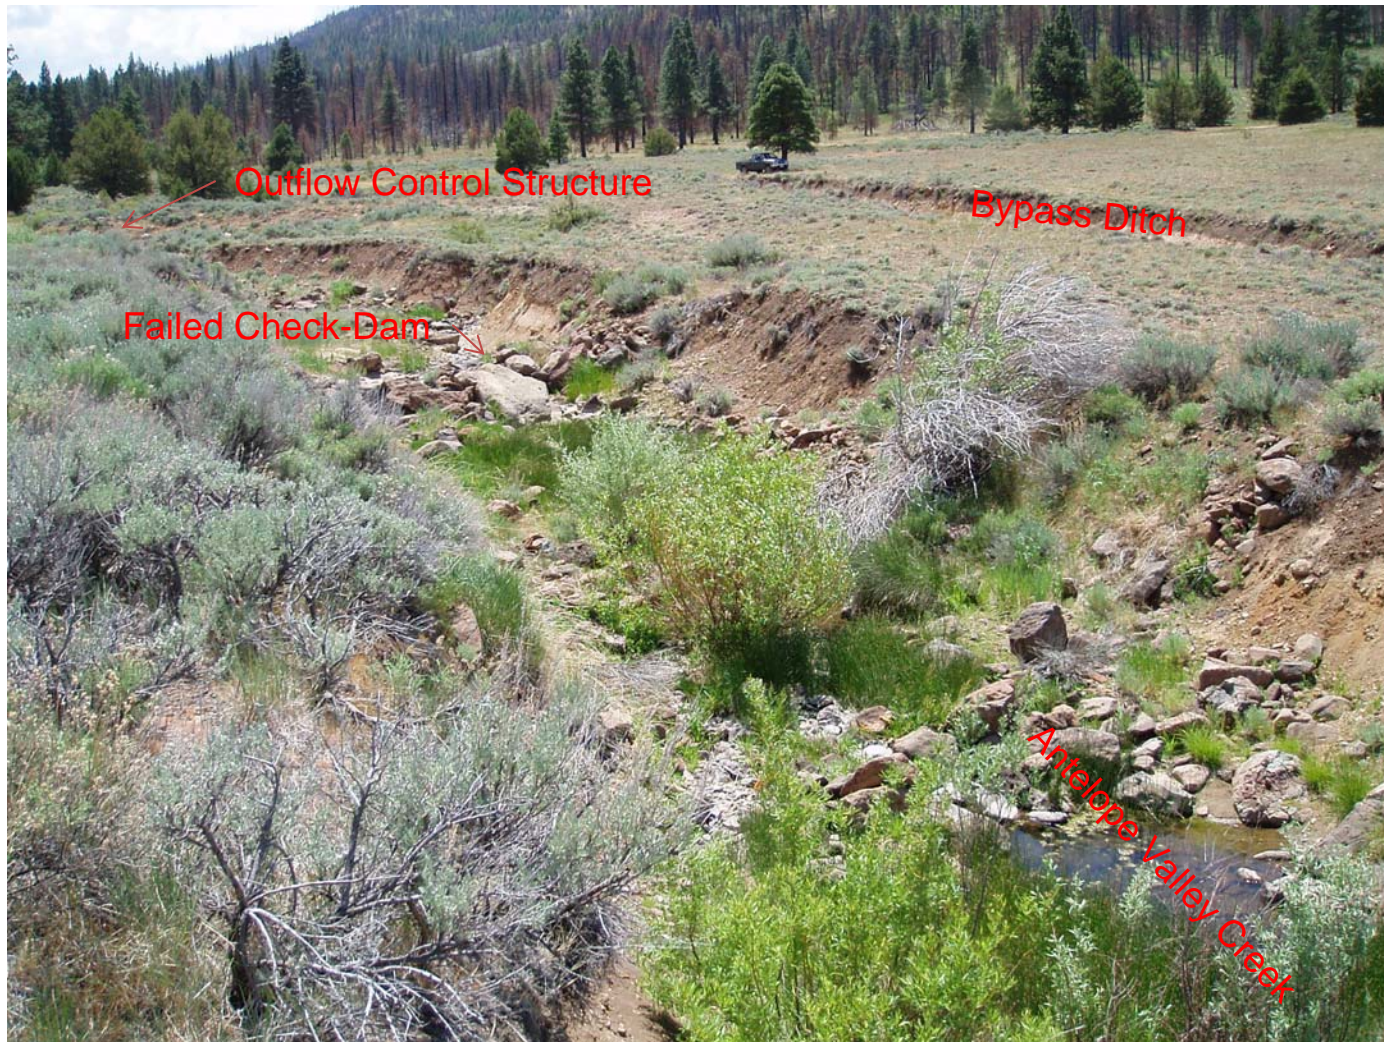
Photo 8

Failing Outlet Channel of Palen Reservoir

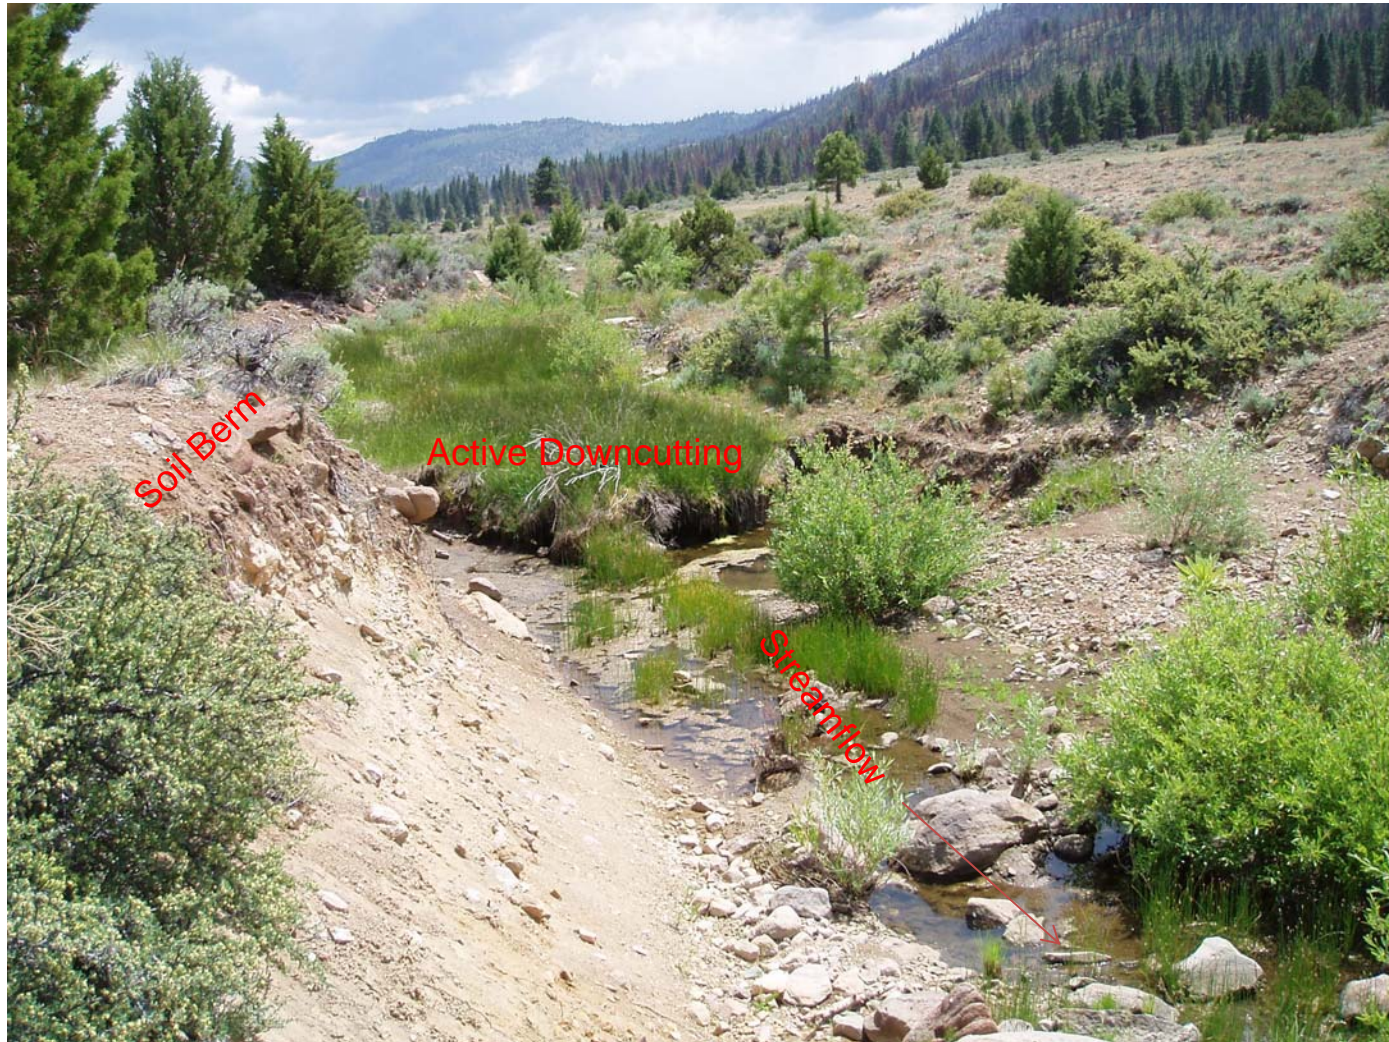
Photo 9

West-side Ditch and Antelope Valley Creek

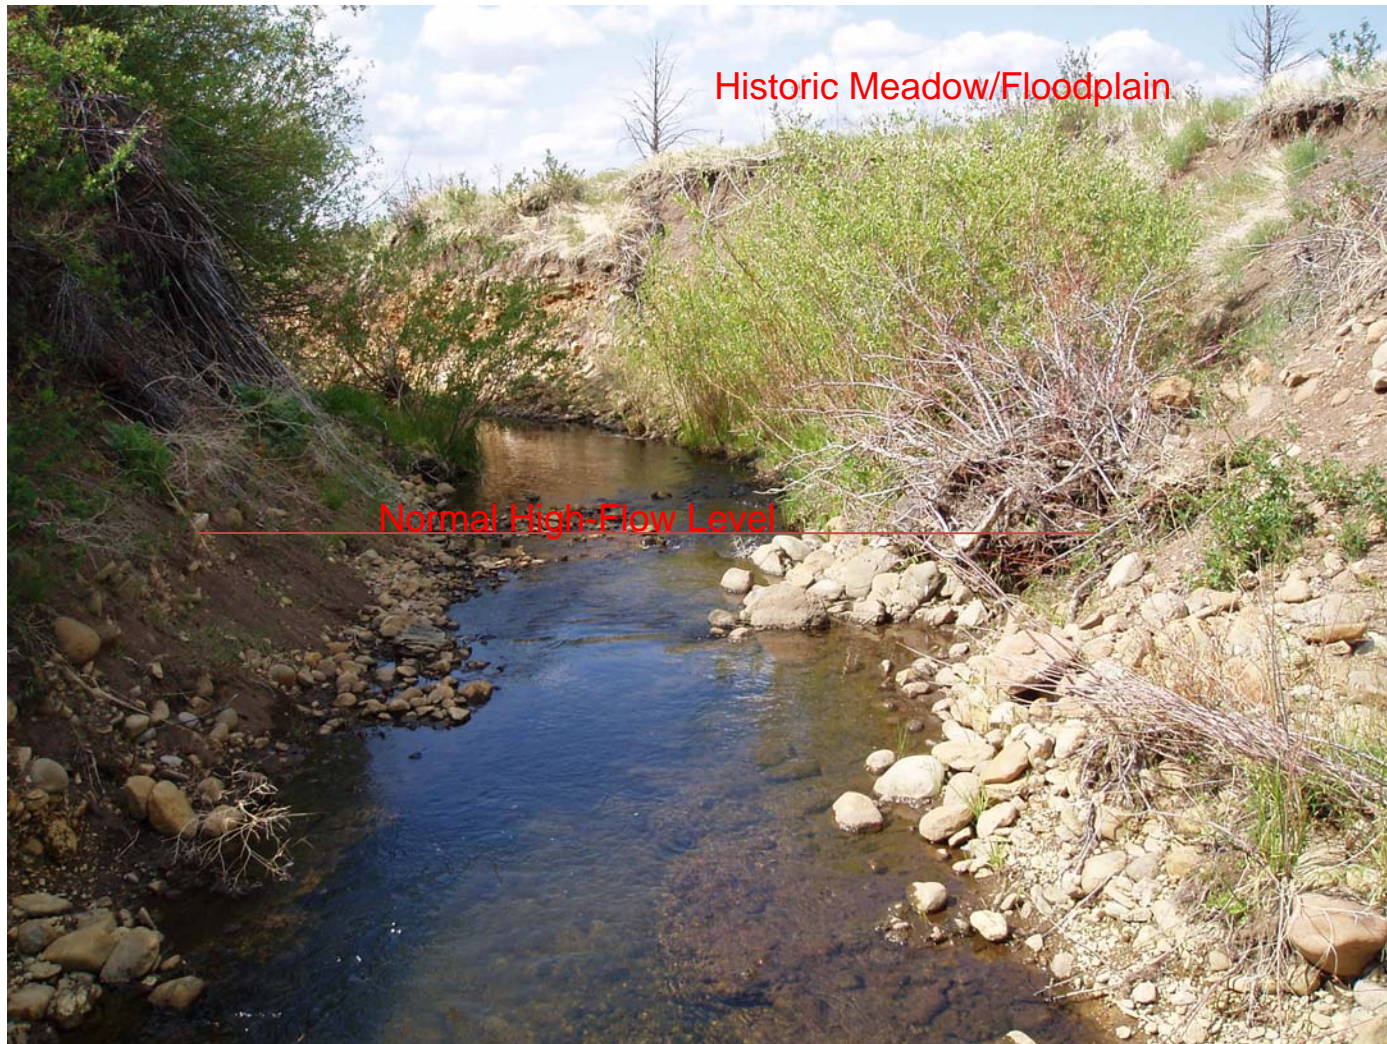
Photo 10

Bear Valley Creek at the Bottom of an Entrenchment
Note No Floodplain so Erosion Forces Against Banks is High

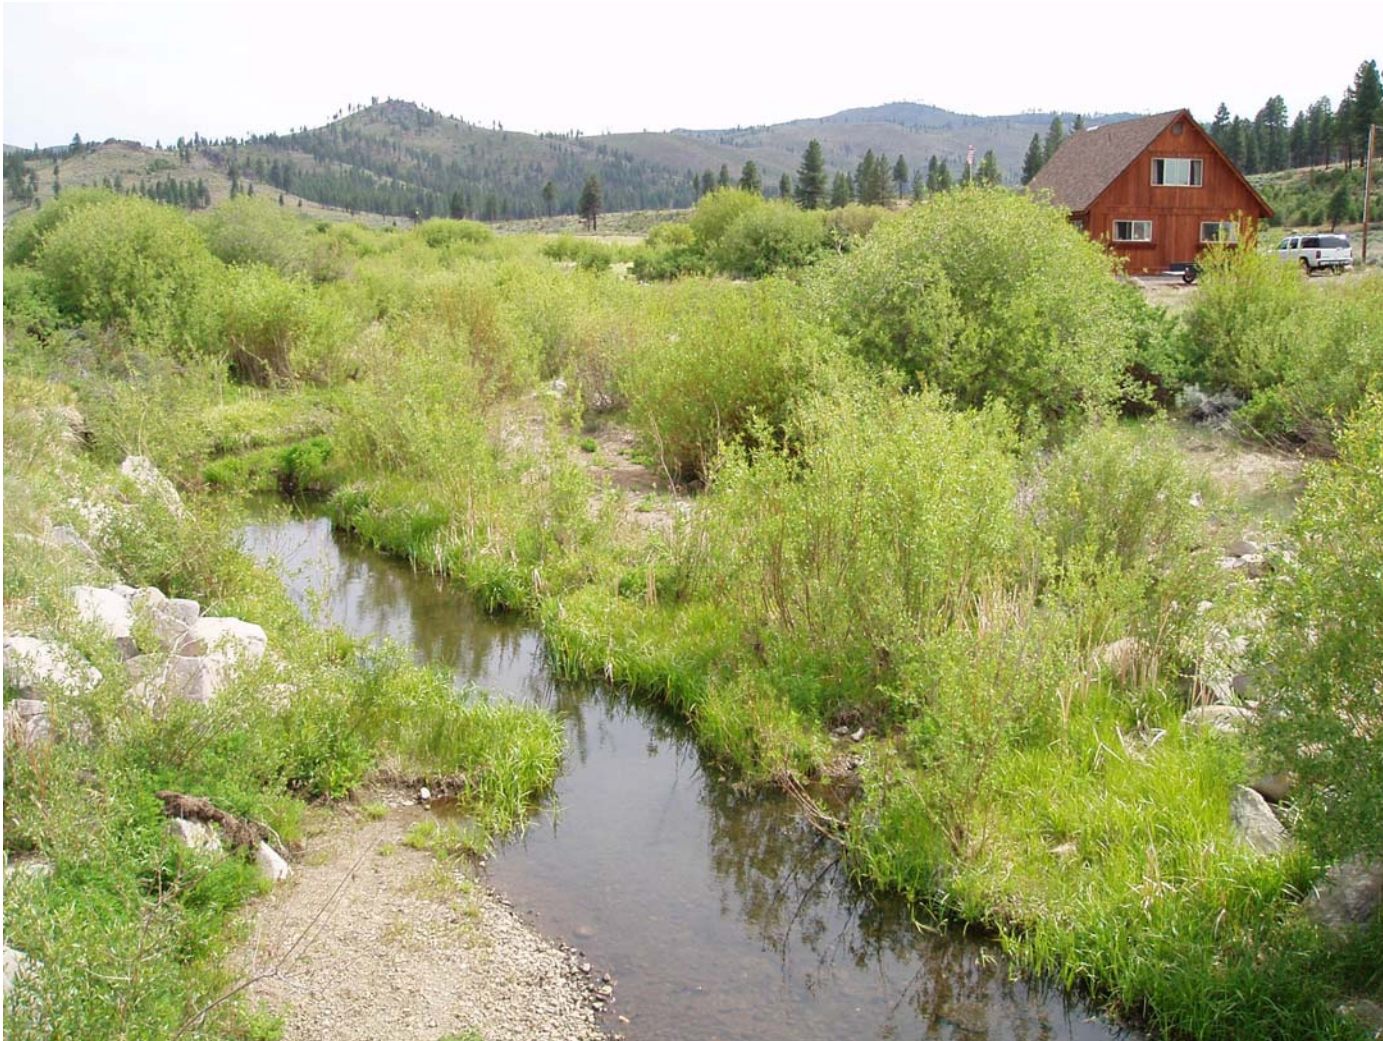
Photo 11

Bear Valley Creek Immediately Upstream of Sierra Brooks Drive

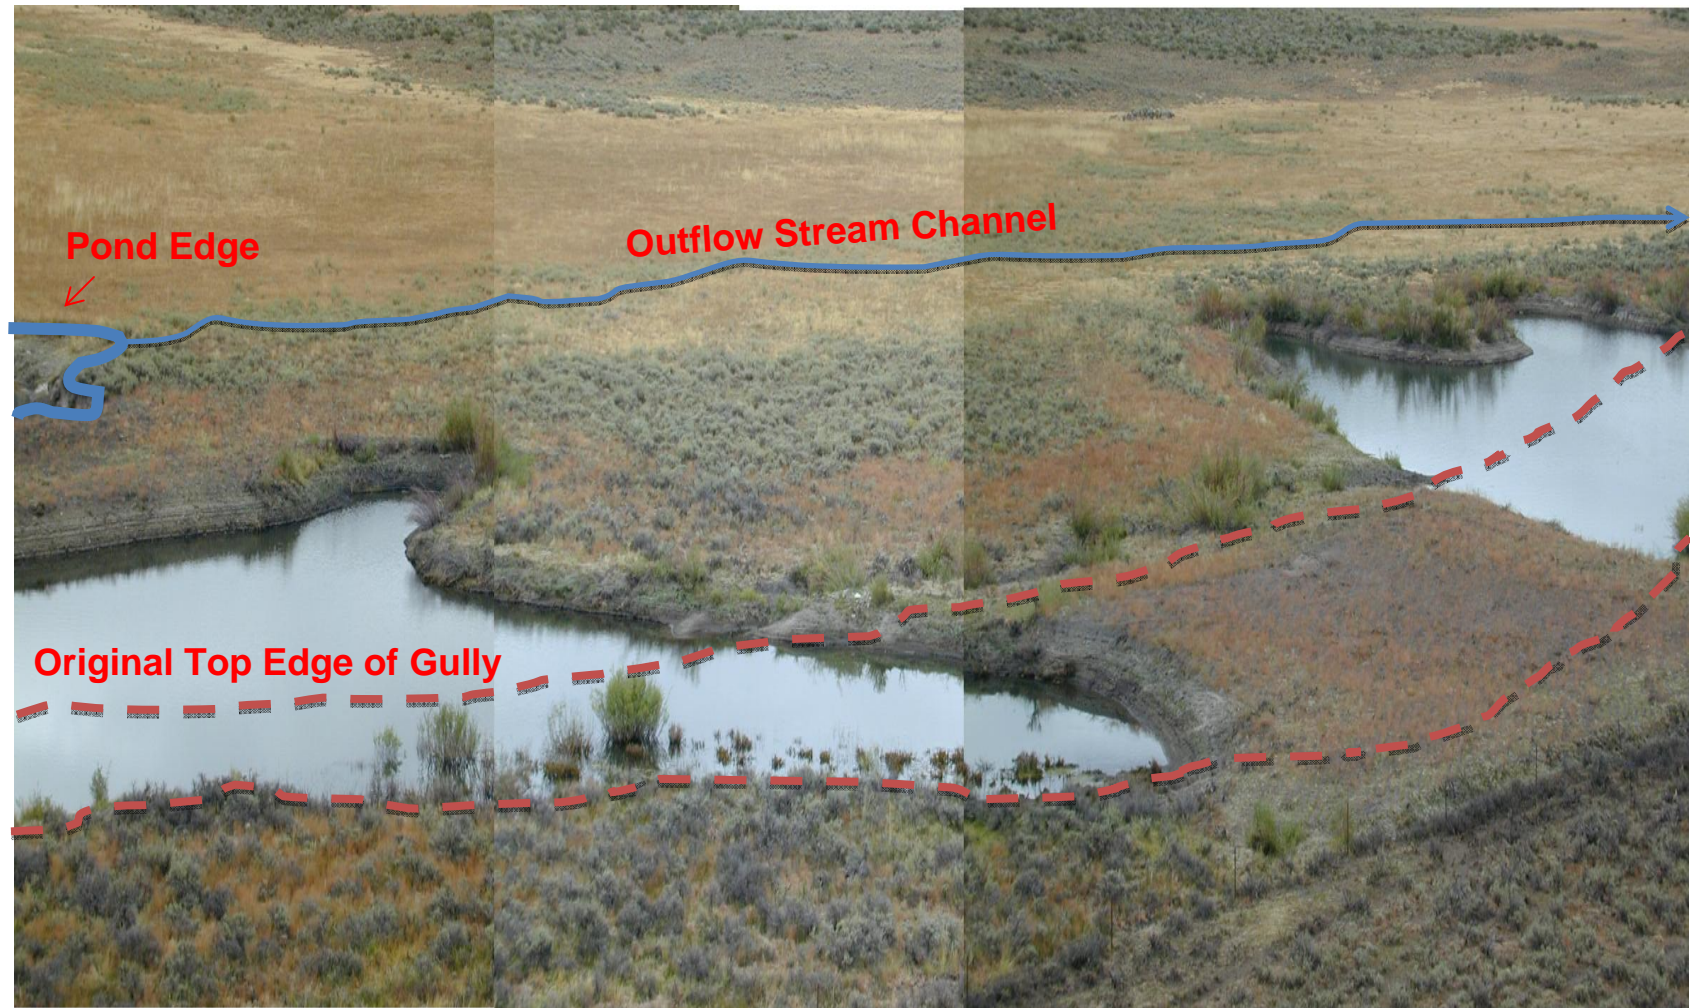
Photo 12

Section of the Last Chance Creek Gully Obliterated Using the Plug-and-Pond Technique (*Note, Late Summer Conditions in this Seasonal Streamflow Section*)

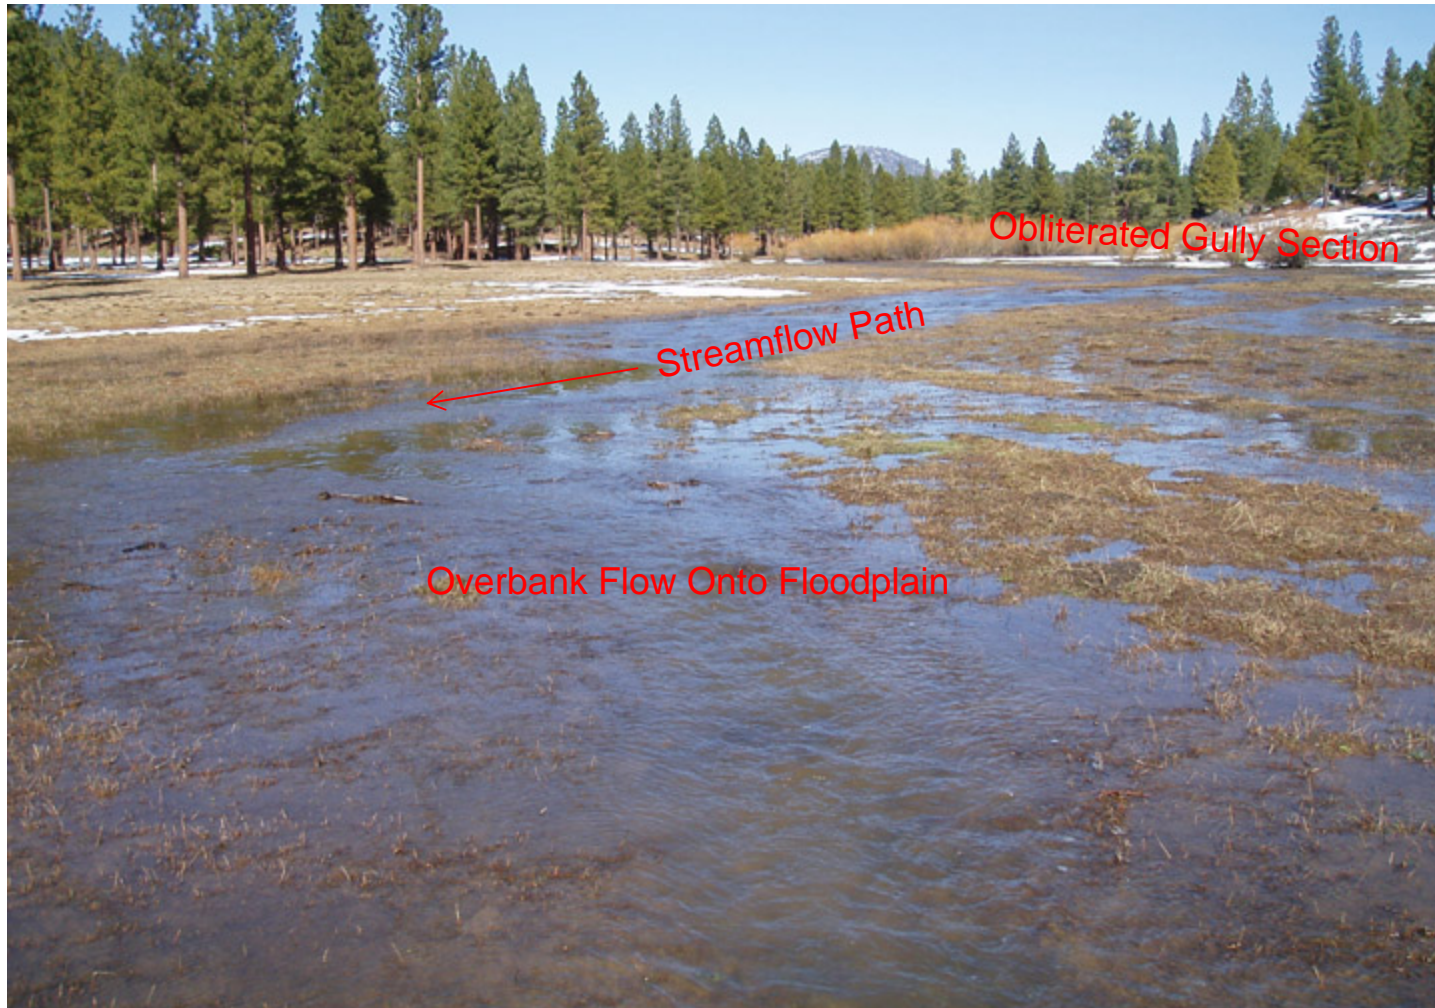
Photo 13

Remnant Channel Streamflow and Flooding onto the Historic Floodplain
Humbug Creek Upstream of Delleker on the Michelson Ranch
